**Flood Control Project Maintenance  
Levee Inspections**  
**LMA District Cover Sheet**  
**Spring 2017 Levee Inspection Results**

**Tehama County Flood Control and Water Conservation District**

**Spring 2017 Levee Inspection Results**

Waterway			Bank	Unit Miles
Unit No. 01 Deer Creek			Left	4.22
	Spring (March - May)	Summer (June - August)	(September - November) Fall	Winter (December - February)
Unit Maintenance Rating (Fall Only)				
Date of Inspection	4/25/2017 - 4/25/2017			
DWR Inspector	Bob Duffey			
Accompanied By	Ryan Teubert Tehama County

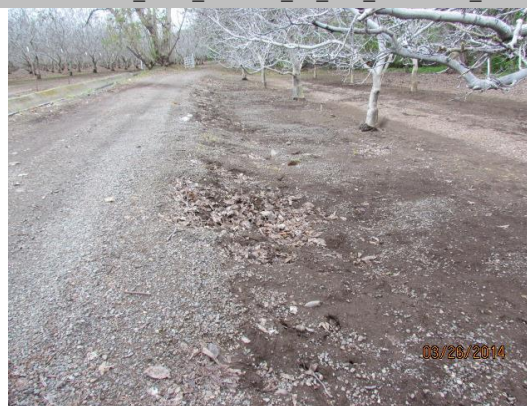
Photo 1 of 1 : SP\_2017\_NA0019\_78\_276\_20170315\_00016.jpg

LM Start	0.45	Rating **	M	Issue No.	276
LM End	0.45	Issue Type +	Ma	Location *	WS
Category	Earthen Levee			GPS Latitude/Longitude	
				Start	End
Item	Slope Stability			39.972377 °	39.972377 °
				-121.988559 °	-121.988559 °
DWR ID	DWR_NA0019_01_s_2014_276				
Comment Code					
S1 : Repair slope instability.					
Inspector Comment

View of the erosion along the waterside slope.

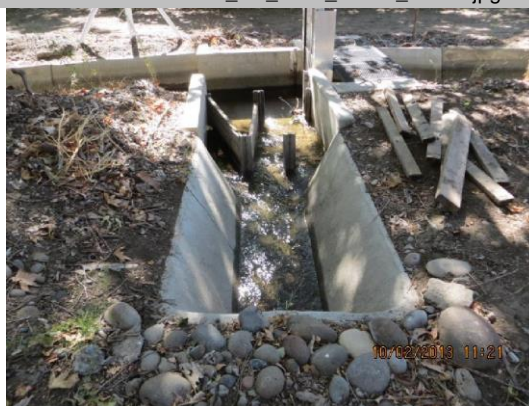
Photo 1 of 3 : UCIP\_SP\_2017\_39839\_39063.jpg

LM Start	0.49	Rating **	M	Issue No.	279
LM End	0.49	Issue Type +	En	Location *	LS
Category	Supplemental			GPS Latitude/Longitude	
				Start	End
Item	DWR UCIP Field Study			39.972280 °	39.972280 °
				-121.989227 °	-121.989227 °
DWR ID					
Comment Code					
Inspector Comment					
FS_ID:39839					
DS_ID:24686					
EP_NO: N/A					
Repair Type: Non-Urgent					
Crossing Status: Found					
UCIP Comments: No permit identified for crossing.					
FIELD_STRUCT_DESC: 20-inch concrete irrigation pipe through the levee 2-feet below the crown. Concrete canal and distribution struture with slat boards on LS shoulder.					
FS Date: 10/2/2013

Concrete canal/distribution box on LS shoulder.

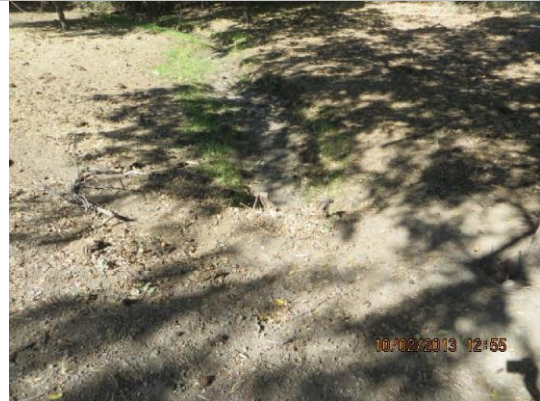
Photo 3 of 3 : UCIP\_SP\_2017\_51437\_36920.jpg

Item	DWR UCIP LMA Responsibility			39.968642 °	39.968642 °	
				-122.010494 °	-122.010494 °	
DWR ID						
Comment Code						
Inspector Comment						
FS_ID:51437 DS_ID:20770 EP_NO: N/A Repair Type: Non-Urgent Crossing Status: Found UCIP Comments: 12/05/2016 Sediment buildup inside pipe (see photo) and sediment buildup on WS blocking flap gate. Crossing has been downgraded from Urgent to Non-Urgent crossing was closed on both WS and LS. (O. Magana - DWR UCIP)10/02/2013 Flapgate blocked by soil buildup. (W. Wylie - DWR UCIP) FIELD_STRUCT_DESC: 24-inch steel drainage pipe through the levee, 1.5 feet below the crown. Flap gate on the waterside (WS) toe. [Additional Reference(s): DWR Levee Log, 1992. USACE Sacramento O&M Manual Unit 509, March 1957, As-built drawings available 50-4-2394 (Station 185+40)]. FS Date: 12/5/2016

Outlet on WS toe.

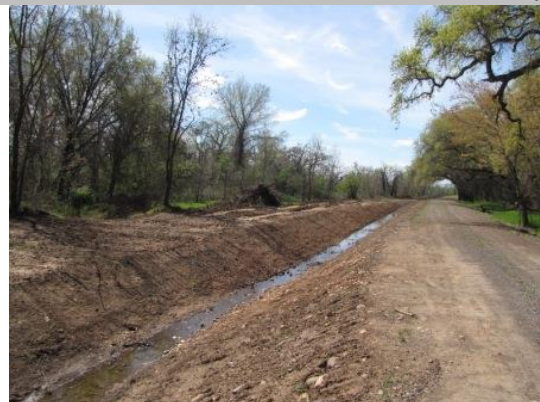
Photo 1 of 1 : SP\_2017\_NA0019\_78\_2\_20170315\_00001.jpg

LM Start	1.79	Rating **	M	Issue No.	2
LM End	2.22	Issue Type +	En	Location *	LS
Category	Earthen Levee			GPS Latitude/Longitude	
				Start	End
Item	Encroachments			39.969443 °	39.966921 °
				-122.012261 °	-122.019469 °
DWR ID	DWR_NA0019_01_s_2012_2				
Comment Code					
DT : Ditch					
Inspector Comment

View of an agricultural ditch along the levee toe.

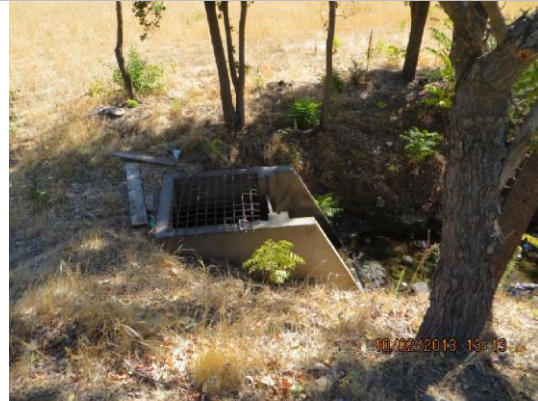
Photo 3 of 3 : UCIP\_SP\_2017\_51438\_36923.jpg

Item	DWR UCIP LMA Responsibility			39.969105°	39.969105°	
				-122.014028°	-122.014028°	
DWR ID						
Comment Code						
Inspector Comment						
FS_ID:51438 DS_ID:20769 EP_NO: N/A Repair Type: Urgent Crossing Status: Found UCIP Comments: 12/05/2016 same as last inspection. Crossing remains "Urgent" WS opened during flood season due to damaged flap gate. (O. Magana - DWR UCIP)10/02/2013 Flapgate missing or burried on WS toe. Pipe partially blocked by soil on WS toe. (W. Wylie - DWR UCIP) FIELD_STRUCT_DESC: 24-inch corrugated metal drainage pipe through the levee, 7 feet below the crown. Flap gate located on the waterside (WS) end. A 5-foot by 5-foot concrete control structure located on the landside (LS) toe. [Additional Reference(s): DWR Levee Log, 1992. USACE Sacramento O&M Manual Unit 509, March 1957, As-built drawing no. 50-4-2394 (Station 176+10)]. FS Date: 12/5/2016

Concrete control structure on LS toe.

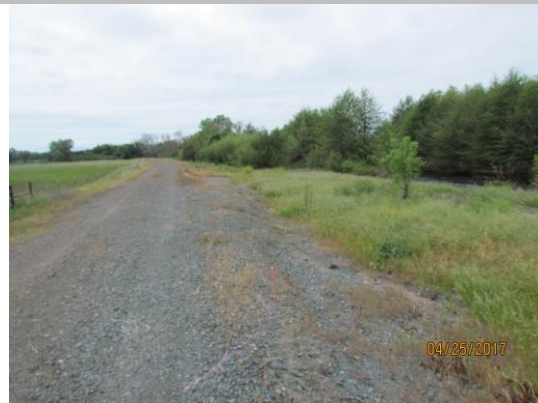
Photo 1 of 1 : SP\_2017\_NA0019\_78\_39\_20170505\_00063.jpg

LM Start	2.53	Rating **	M	Issue No.	39
LM End	2.53	Issue Type +	Ma	Location *	WS
Category	Earthen Levee			GPS Latitude/Longitude	
				Start	End
Item	Erosion / Bank Caving			39.966675 °	39.966675 °
				-122.024988 °	-122.024988 °
DWR ID	DWR_NA0019_01_s_2017_39				
Comment Code					
E2 : Schedule repair of erosion site prior to the next inspection.					
Inspector Comment					
Repair the erosion along the water side slope.

View of erosion along the waterside slope.

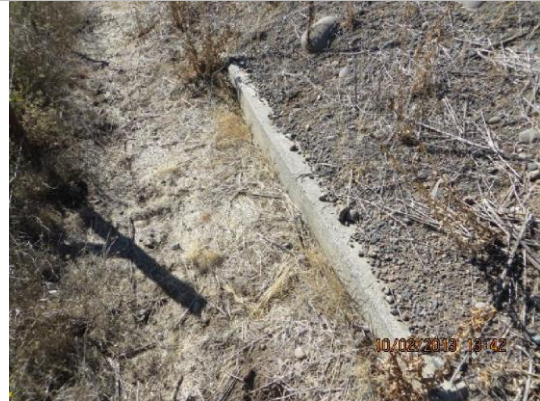
Photo 1 of 1 : UCIP\_SP\_2017\_22823\_38941.jpg

LM Start	2.57	Rating **	M	Issue No.	283
LM End	2.57	Issue Type +	Ma	Location *	WS
Category	Supplemental			GPS Latitude/Longitude	
				Start	End
Item	DWR UCIP LMA Responsibility			39.966363 °	39.966363 °
				-122.025755 °	-122.025755 °
DWR ID					
Comment Code					
Inspector Comment					
FS_ID:22823					
DS_ID:20877					
EP_NO: N/A					
Repair Type: Non-Urgent					
Crossing Status: Found					
UCIP Comments: Headwall covered with soil. Needs to be cleared at both ends.					
FIELD_STRUCT_DESC: 24-inch Corrugated mtal pipe through the levee 5-feet below the crown. Calco automatic drainage gate.					
Originally included in O+M manual (1957). As-built drawings available 50-4-2394.					
FS Date: 10/2/2013

Concrete headwall on LS toe.

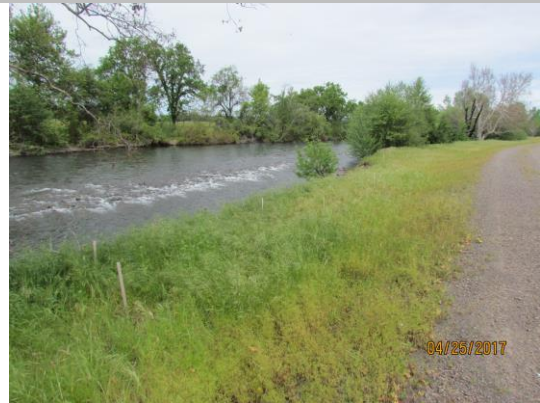
Photo 1 of 1 : SP\_2017\_NA0019\_78\_43\_20170505\_00064.jpg

LM Start	2.76	Rating **	U	Issue No.	43
LM End	2.78	Issue Type +	Ma	Location *	WS
Category	Earthen Levee			GPS Latitude/Longitude	
				Start	End
Item	Erosion / Bank Caving			39.964990 °	39.964763 °
				-122.028740 °	-122.029082 °
DWR ID	DWR_NA0019_01_s_2017_43				
Comment Code					
E2 : Schedule repair of erosion site prior to the next inspection.					
Inspector Comment					
Repair the erosion along the water side slope.

View of erosion along waterside toe.

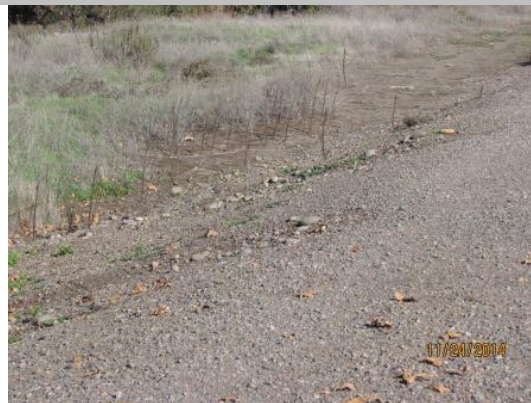
Photo 1 of 1 : SP\_2017\_NA0019\_78\_38\_20170315\_00012.jpg

LM Start	2.86	Rating **	M	Issue No.	38
LM End	2.86	Issue Type +	Ma	Location *	LS
Category	Earthen Levee			GPS Latitude/Longitude	
				Start	End
Item	Slope Stability			39.963928 °	39.963928 °
				-122.030120 °	-122.030120 °
DWR ID	DWR_NA0019_01_f_2014_38				
Comment Code					
S1 : Repair slope instability.					
Inspector Comment

View of erosion from the cattle on both slopes.

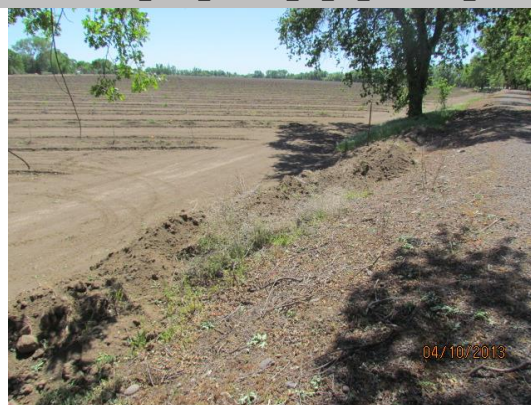
Photo 1 of 1 : SP\_2017\_NA0019\_78\_20\_20170315\_00007.jpg

LM Start	2.88	Rating **	M	Issue No.	20
LM End	2.88	Issue Type +	Ma	Location *	LS
Category	Earthen Levee			GPS Latitude/Longitude	
				Start	End
Item	Slope Stability			39.963709 °	39.963709 °
				-122.030384 °	-122.030384 °
DWR ID	DWR_NA0019_01_s_2013_20				
Comment Code					
S1 : Repair slope instability.					
Inspector Comment

View of the erosion along the landside slope.

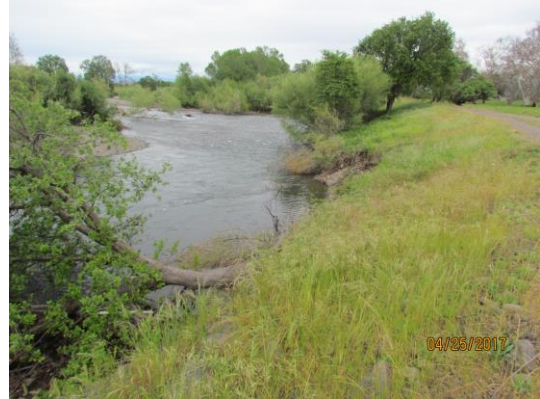
Photo 1 of 1 : SP\_2017\_NA0019\_78\_44\_20170505\_00065.jpg

View of erosion along the waterside slope.

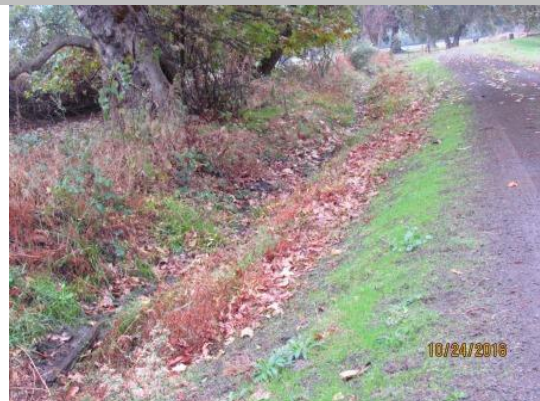
Photo 1 of 1 : SP\_2017\_NA0019\_78\_35\_20170315\_00010.jpg

View of the vegetation along the landside slope and toe.

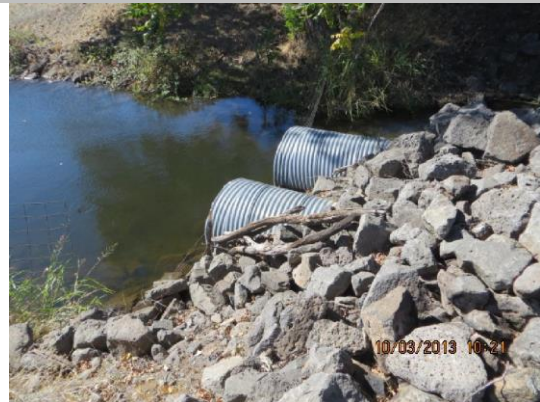
Photo 1 of 3 : UCIP\_SP\_2017\_39836\_39073.jpg

LM Start	3.60	Rating **	M	Issue No.	287
LM End	3.60	Issue Type +	En	Location *	LS
Category	Supplemental			GPS Latitude/Longitude	
				Start	End
Item	DWR UCIP Field Study			39.945952 °	39.945952 °
				-122.054259 °	-122.054259 °
DWR ID					
Comment Code					
Inspector Comment					
FS_ID:39836 DS_ID:24688 EP_NO: N/A Repair Type: Non-Urgent Crossing Status: Found UCIP Comments: No permit identified for this crossing. Brush should be removed from flapgate outlet. FIELD_STRUCT_DESC: 48-inch corrugated metal drainpipe through the levee, 6-feet below the crown. Flap gate on the waterward end. FS Date: 10/3/2013

Pipe visible on LS toe.

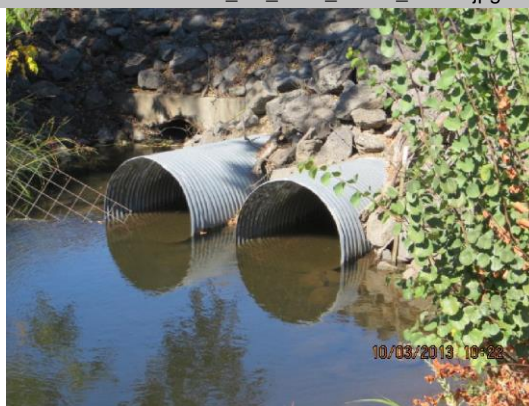
Photo 2 of 3 : UCIP\_SP\_2017\_39836\_39072.jpg

Pipe visible on LS toe.

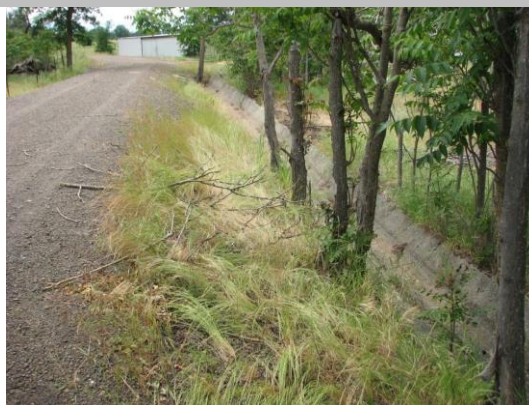
Photo 1 of 1 : SP\_2017\_NA0019\_79\_11\_20170315\_00006.jpg

View of a concrete-lined ditch along the levee toe.

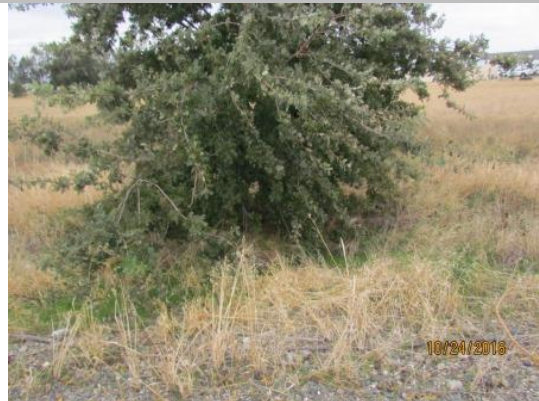
Photo 1 of 1 : SP\_2017\_NA0019\_81\_13\_20170315\_00008.jpg

View of a tree with overhanging branches.

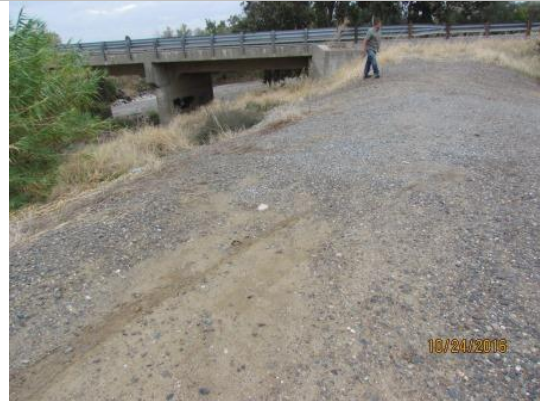
Photo 1 of 1 : SP\_2017\_NA0019\_81\_27\_20170315\_00017.jpg

View of the slope instability caused by vehicles.

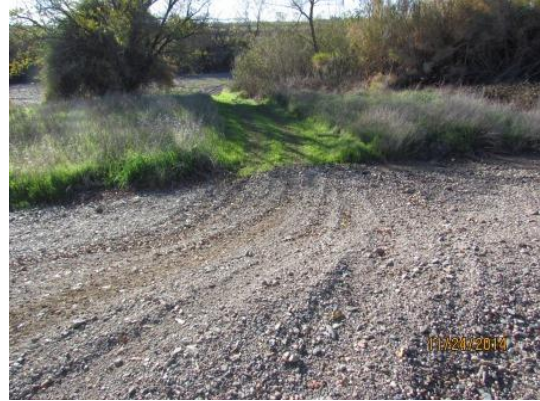
Photo 1 of 1 : SP\_2017\_NA0019\_81\_16\_20170315\_00011.jpg

View of the slope instability caused by vehicles along the waterside slope.

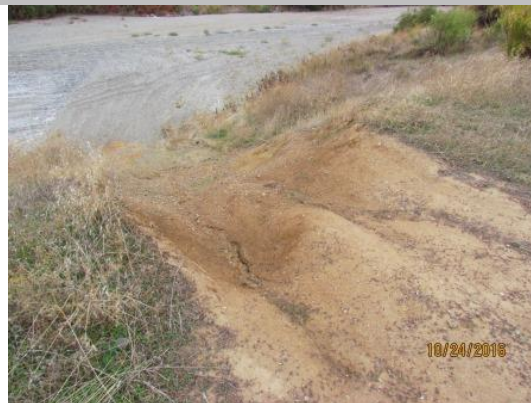
Photo 1 of 1 : SP\_2017\_NA0019\_81\_29\_20170315\_00018.jpg

View of the slope instability caused by vehicles along the waterside slope.

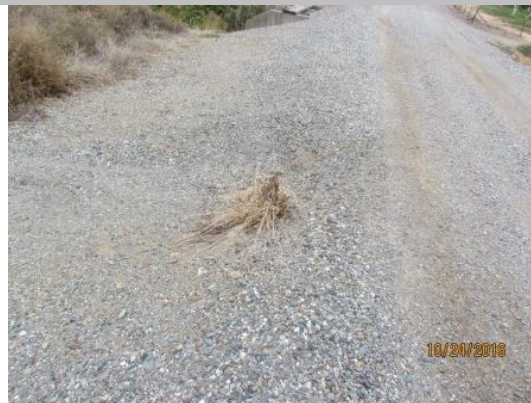
Photo 1 of 2 : SP\_2017\_NA0019\_81\_3\_20170315\_00004.jpg

View of a dip along the levee slope.

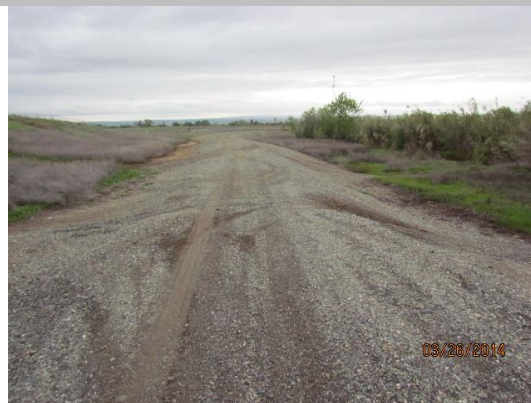
Photo 2 of 2 : SP\_2017\_NA0019\_81\_3\_20170315\_00003.jpg

View of the levee slope damaged by vehicle traffic.

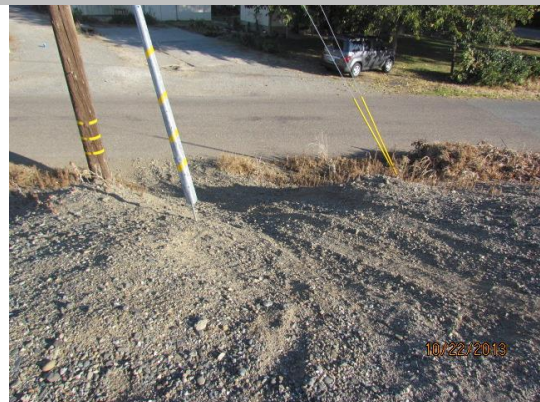
Photo 1 of 1 : SP\_2017\_NA0019\_81\_12\_20170315\_00007.jpg

View of the slope instability caused by vehicles along the landside slope.

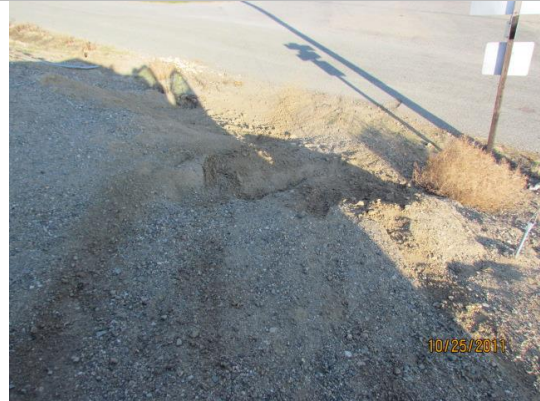
Photo 1 of 1 : SP\_2017\_NA0019\_81\_20\_20170315\_00013.jpg

View of the slope instability caused by vehicles along the landside slope.

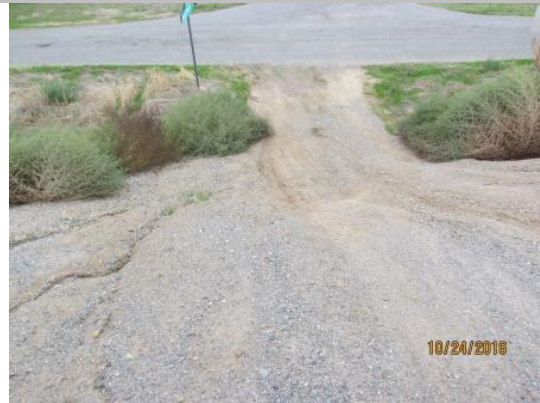
Photo 1 of 1 : SP\_2017\_NA0019\_81\_2\_20170315\_00002.jpg

View of the slope instability caused by vehicles along the landside slope.

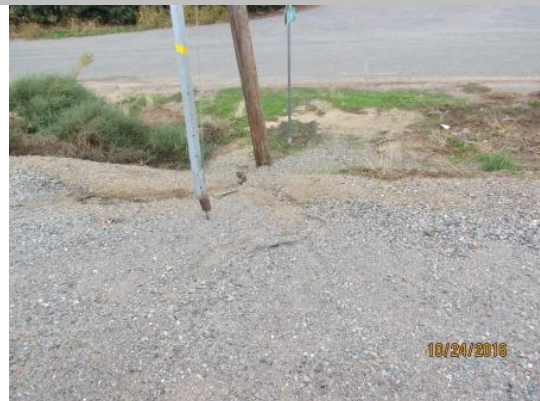
Photo 1 of 1 : SP\_2017\_NA0019\_81\_32\_20170315\_00021.jpg

View of the slope instability caused by vehicles along the landside slope.

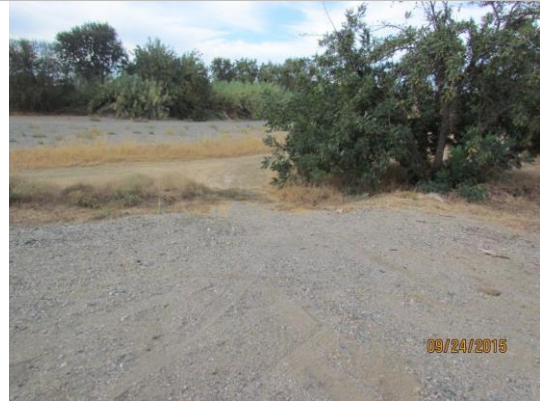
Photo 1 of 1 : SP\_2017\_NA0019\_81\_10\_20170315\_00006.jpg

View of the slope instability caused by vehicles along the landside slope.

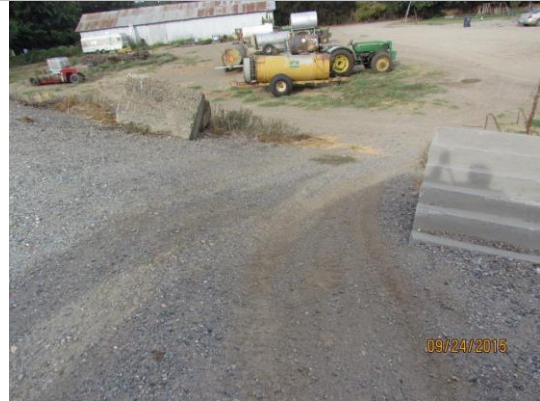
Photo 1 of 1 : SP\_2017\_NA0019\_81\_25\_20170315\_00015.jpg

View of the slope instability caused by vehicles along the landside slope.

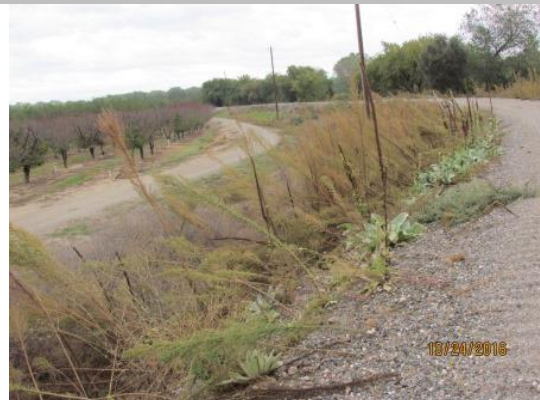
Photo 1 of 1 : SP\_2017\_NA0019\_81\_40\_20170315\_00024.jpg

View of the annual grass along the landside slope.

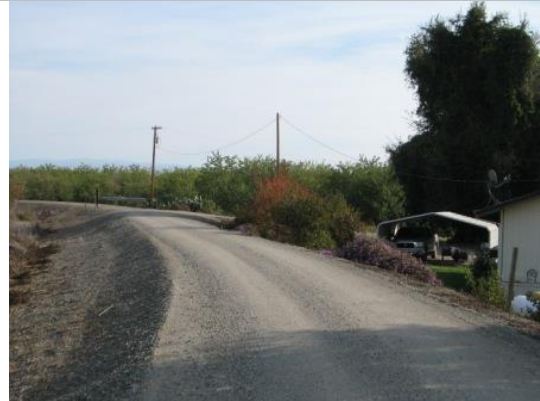
Photo 1 of 1 : SP\_2017\_NA0019\_82\_2\_20170315\_00001.jpg

View of the landscaping along the slope.

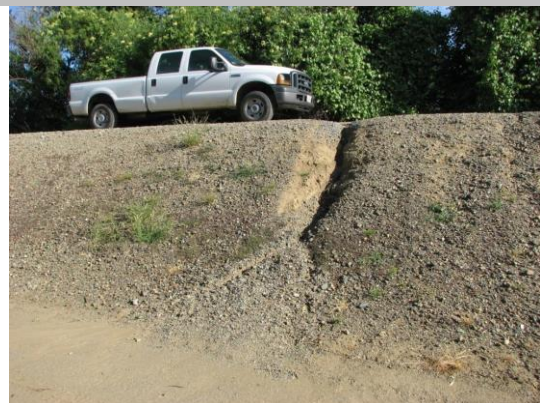
Photo 1 of 1 : SP\_2017\_NA0019\_82\_10\_20170315\_00004.jpg

View of the erosion along the landside slope.

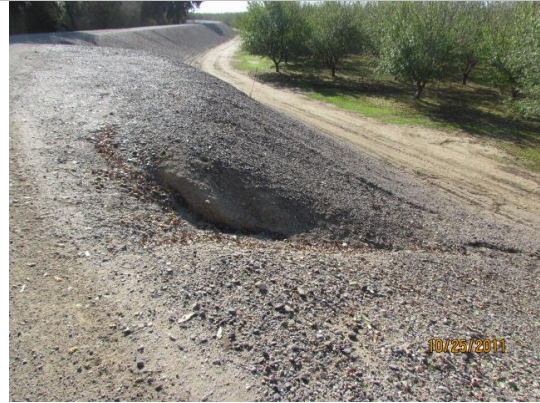
Photo 1 of 1 : SP\_2017\_NA0019\_82\_7\_20170315\_00002.jpg

View of the erosion along the landside slope.

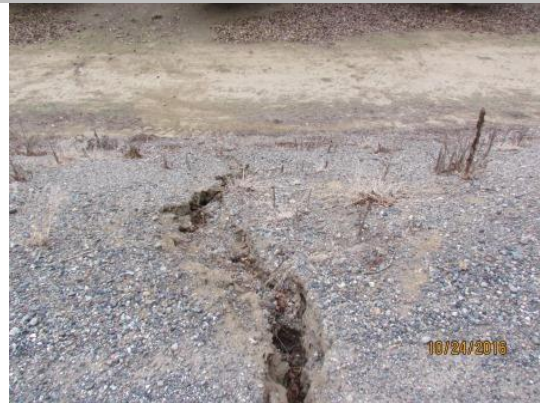
Photo 1 of 1 : SP\_2017\_NA0019\_82\_19\_20170315\_00008.jpg

View of the erosion along the landside slope.

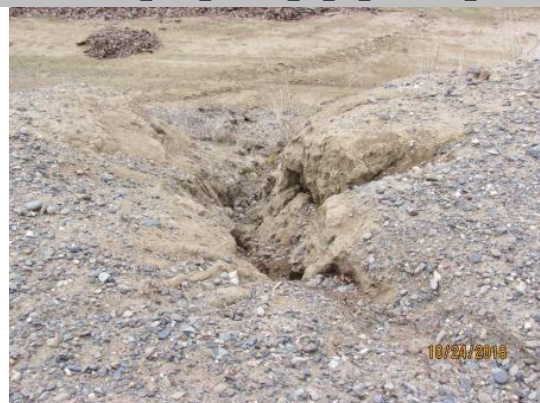
Photo 1 of 1 : SP\_2017\_NA0019\_82\_18\_20170315\_00007.jpg

View of the erosion along the landside slope.
